Failure Investigation Report

22 November 2009 Failure of Piping at
EnCana Swan Wellsite A5-7-77-14 L W6M

February 4, 2010

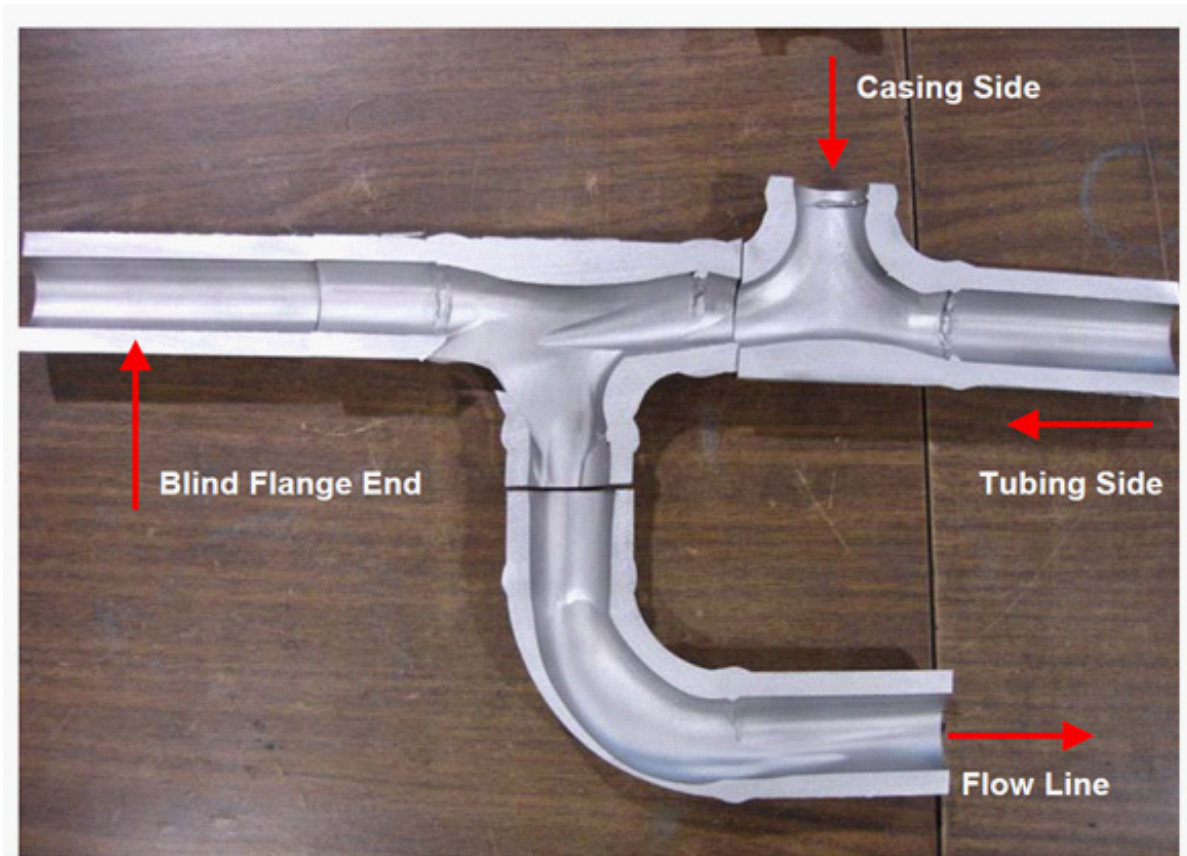
Figure 2 – Photograph of Eroded Tee

- The failed piping consisting of the failed tee (60.3 mm x 11.07 mm XXS A420-WPL6 tee) and the downstream elbow (see figure 2 on next page) exhibited significant internal erosion;

- A significant amount of sand was recovered from the failed piping and determined to be sand injected into the gas producing formation during fracture operations at this location;

Based on the preceding observations and statements, the Commission has determined the root cause of the piping failure which occurred the morning of 22 November 2009 at the EnCana well A05-07-077-14-W6M was internal erosion of the wall of the 60.3 mm x 11.07 mm XXS tee caused by flowing fracture sand suspended in the gas stream.

1. The 22 November 2009 failure of the A420 WPL-6 60.3 mm outside diameter (OD) x 11.07 mm wall thickness (WT) (XXS) tee at A5-7-77-14-W6M was caused by internal erosion of the wall resulting from flowing fracture sand suspended in the gas stream.

1. EnCana shall place emergency shutdown (ESD) valves immediately adjacent to (within one metre of) the wellhead at all wellsites within British Columbia where internal abrasion from sand returns may present a hazard. At these locations, bends between the wellhead and the ESD valves are not permitted. EnCana shall review the location of ESD valves at all existing wells within British Columbia and shall file with the Commission a plan for the necessary modifications. The plan shall be filed with the Commission for approval on or before 30 May 2010.
