Engineering/Technical Investigation Report

# Loss of Well Control at Suncor Altares

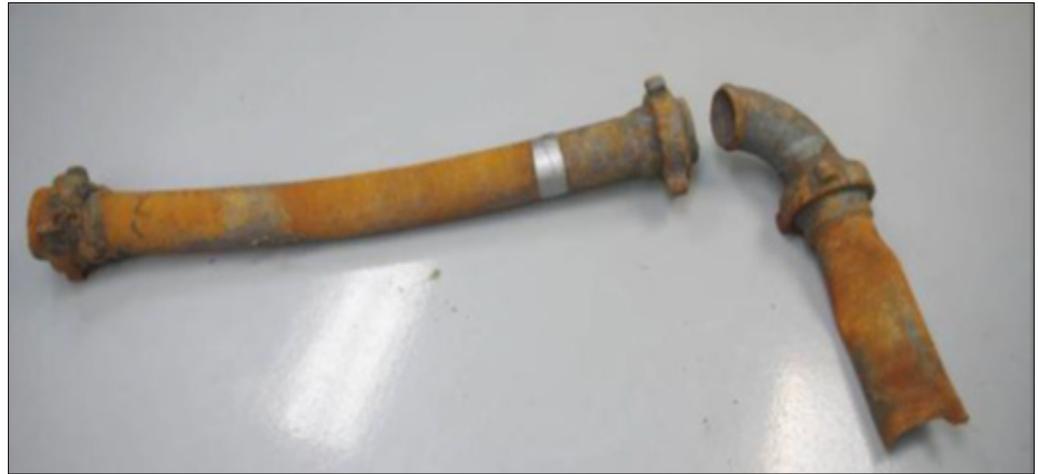
Acuren was able to identify one failure that occurred on the drilling fluid (mud) return line between the managed pressure drilling separator and the shale shaker that did not occur as a result of damage caused by the fire. A metallographic section of the components and observation of the failure indicated that a pre-existing fatigue crack was present. The presence of such a pre-existing crack would render the joint susceptible to failure with the application of a relatively small bending load. Acuren did not find any evidence that any of the piping components were damaged as a result of overpressuring.

Figure 2: Photograph showing the drilling fluid return line failure location.

Considering the piping configuration, witness statements and analysis of materials, it appears the failure of the drilling fluid return line was a contributing factor to the loss of well control. While the failure of the drilling fluid return line is believed to be a significant event that contributed to the blowout, there are a number of other factors that must be considered in order to understand the cause of the blowout.

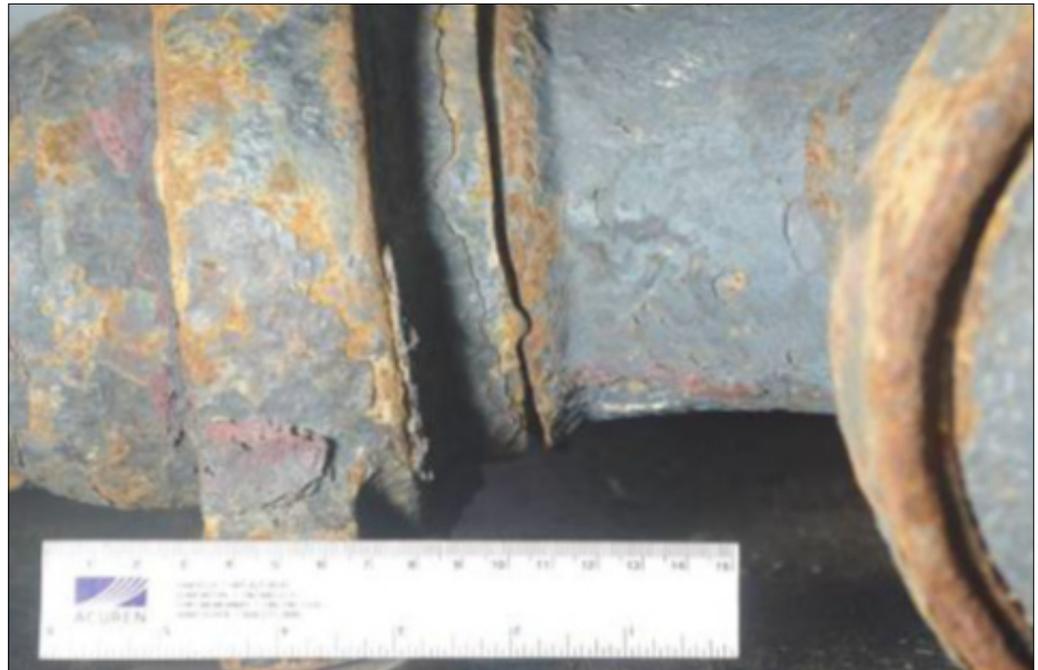
Figure 3: Photograph showing the fracture on the drilling fluid return line.

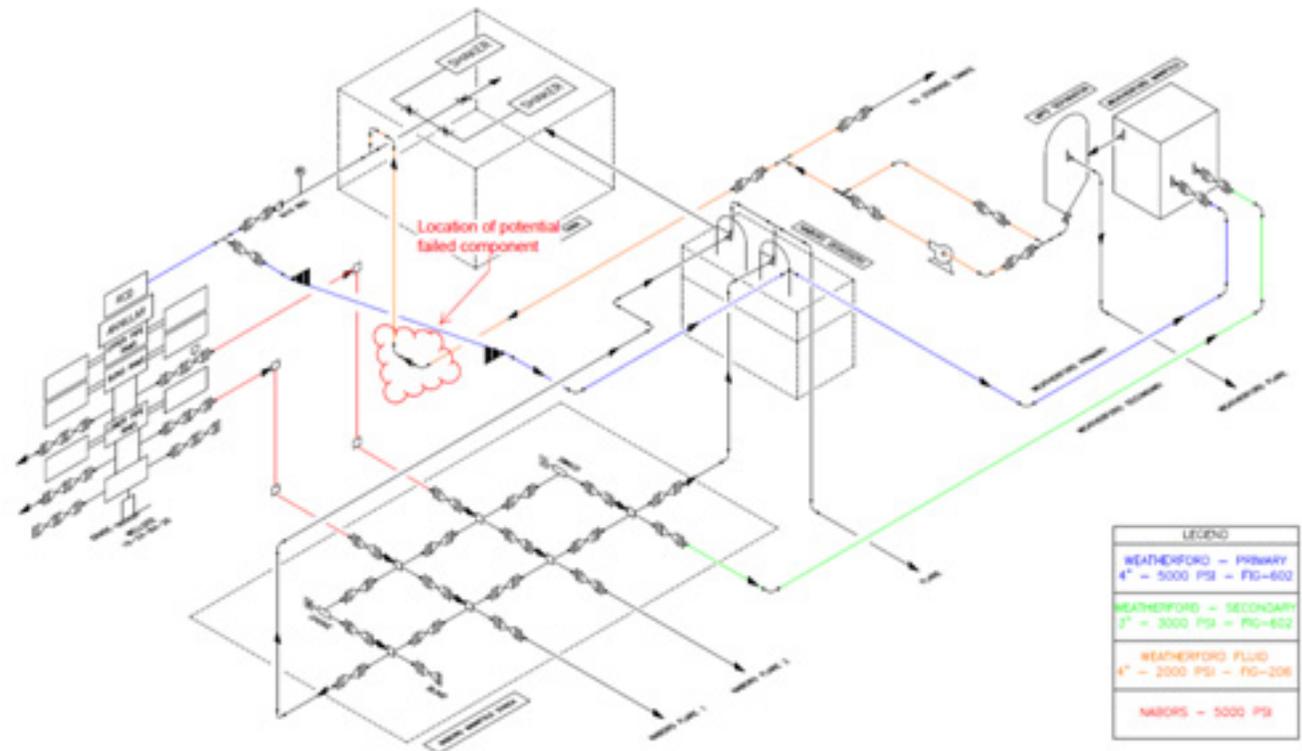
Figure 4: Isometric drawing of the Nabors 9 piping configuration showing the mud return line failure location (not to scale).

3. The MPD program stated the MPD equipment should not be used if the casing pressure exceeded (>90 per cent of posted MACP) 12,960 kPa. Casing pressure exceeded this threshold and the rig crew should not have been attempting to conduct well control operations through the MPD equipment.
4. The drilling fluid return line on the MPD system failed. It is believed this failure resulted in the loss of well control.
